The Coral Bay Community Council CARE Project

Cistern Water Quality Testing & Results in Coral Bay, St. John, US Virgin Islands

Barry Devine, Ph.D., CARE Research Coordinator,
and Sharon Coldren, M.Sc., CBCC Executive Director
March 25, 2011

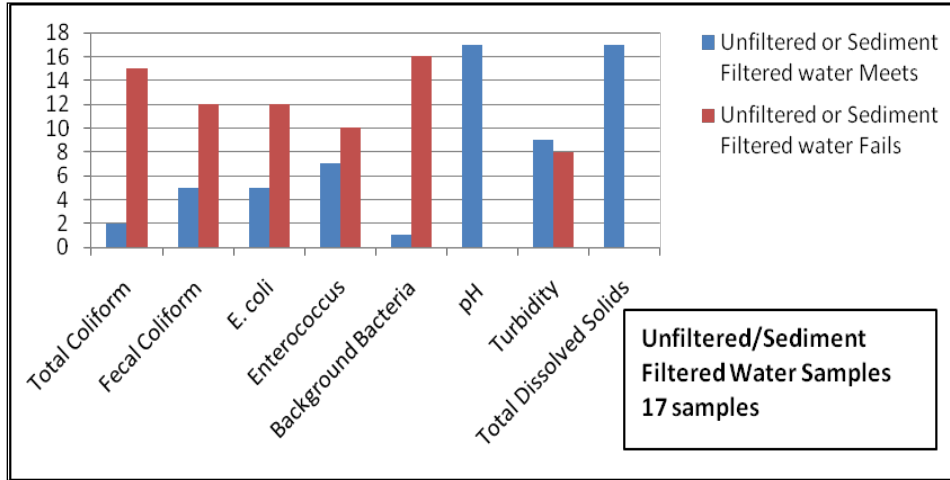
Cistern Test Results by Group

Meets: Absent (A) BLUE

Fails: Present (P) RED

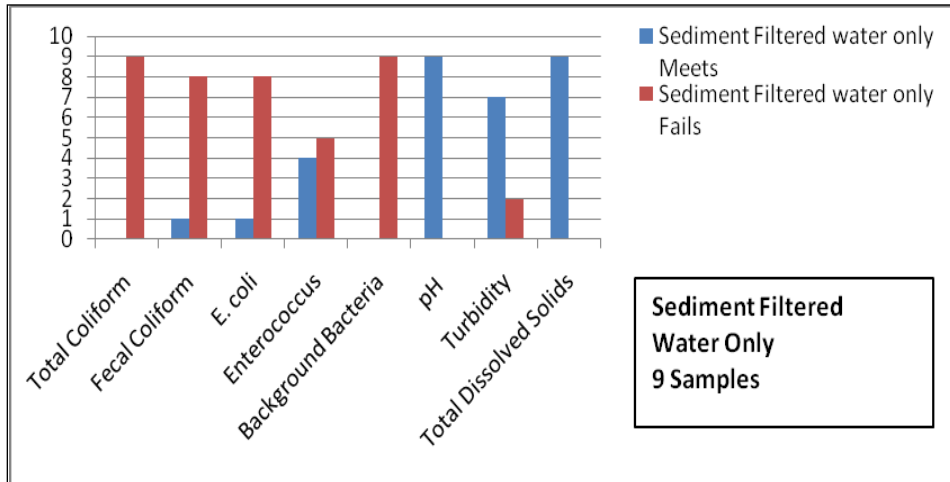
Meets: Absent (A) BLUE

Fails: Present (P) RED

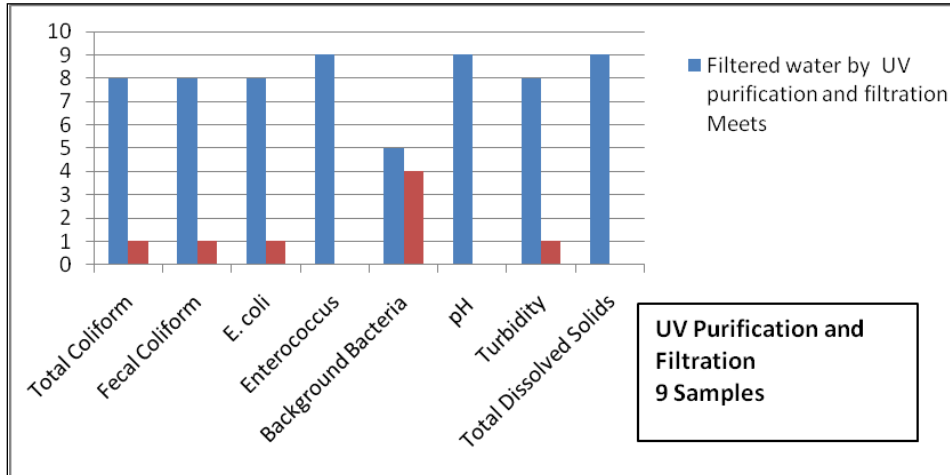
Meets: Absent (A) BLUE

Fails: Present (P) RED

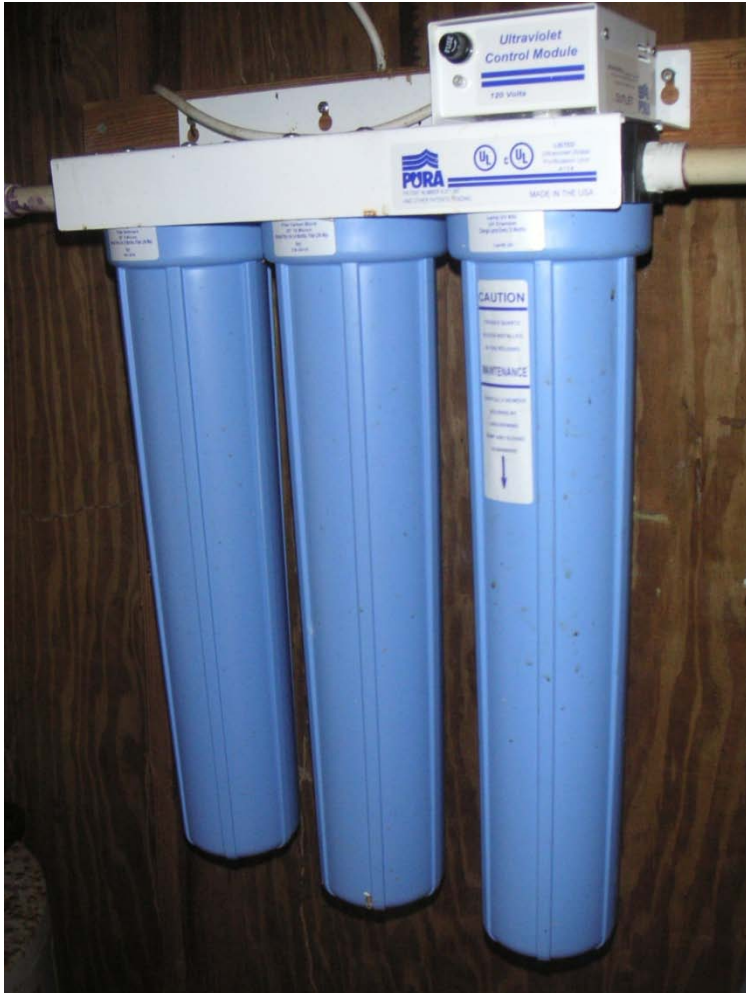
Regular purification unit: 1 sediment filtration chamber, 1 charcoal filter chamber and 1 UV Lamp chamber. These filter units are installed by a plumber with shut off valves in the pipes, so filter chambers can be opened and filters replaced routinely:

3. Chlorine and bleach are generally not considered to be smart and healthy maintenance (see below).
4. If the home is not used for a while, the water in the pipes should be flushed through the system, so that freshly purified water is drunk.
5. Sediment filters should be changed every few months (depending on water usage); UV light bulbs should be checked routinely and changed out on a schedule.

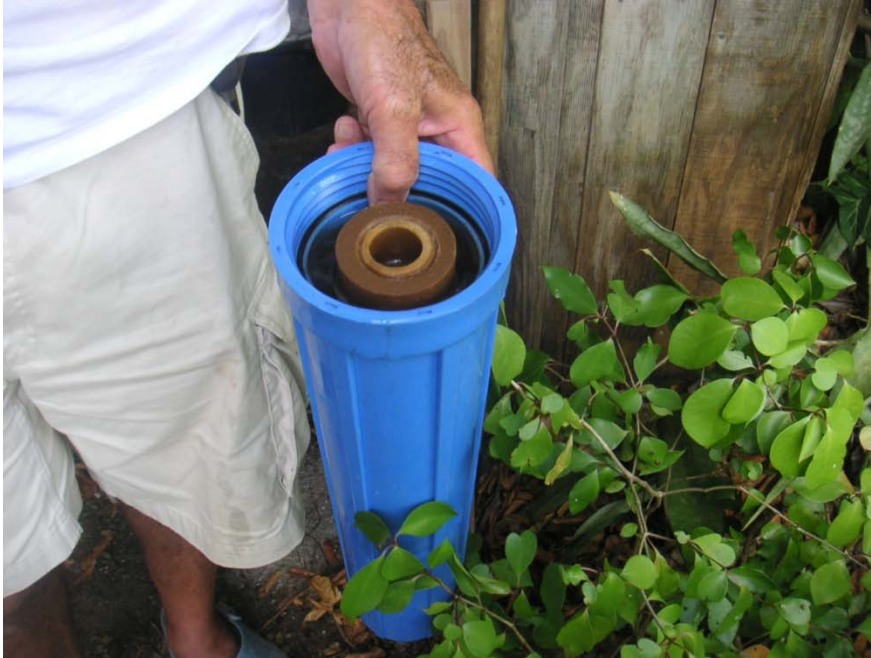
Removing the Filter:

Dirty filter and dirty water – in first chamber.

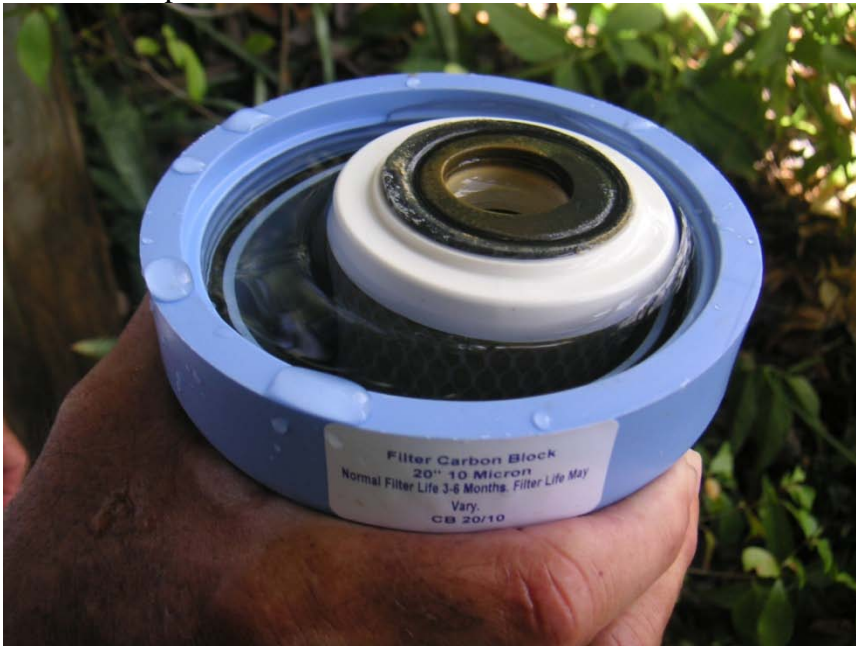
After two dirty sediment filter chambers – note that the water is clear around the “dirty” charcoal filter to be replaced too:

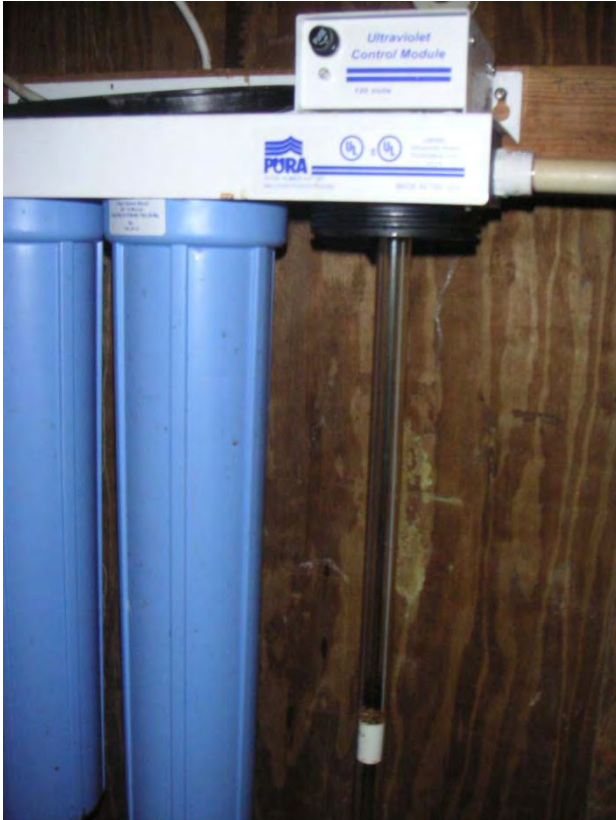
- The unfiltered vs. UV purified samples from the same cisterns in 2 cases showed pre-filter contamination of water sample, but no contamination after UV Purification.
- The single contaminated UV Filtered sample was found to have a dirty filter and a UV bulb burned out.
- In general Filtered/UV water has significantly less or no bacteria present in samples.
- Sediment filters do not remove or filter bacteria and can be breeding sites. There was no improvement in biological contaminants absence with use of filters only.
- In some unfiltered cisterns, bacteria were present, the water drunk on a continuing basis and residents reported no signs of intestinal distress.
- The pH of the water ranged from 6.45-8.51.
- The turbidity ranged from 0.21 – 3.65 ntu
- The total dissolved solids (TDS) ranged from 21-342 mg/l.

Burnt out UV bulb – in glass sleeve – this takes instructions to remove correctly!

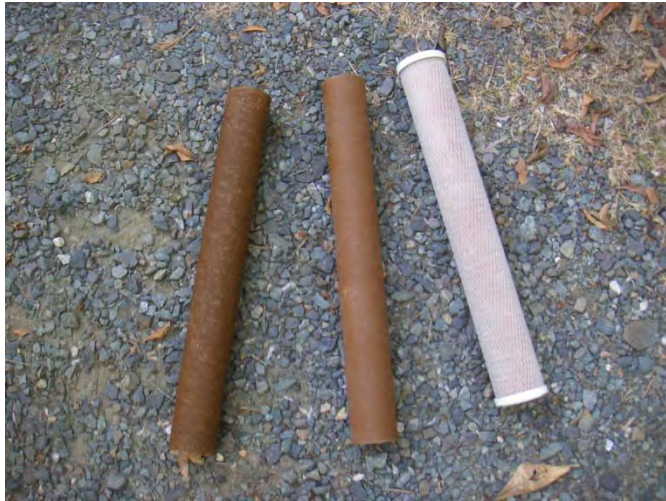
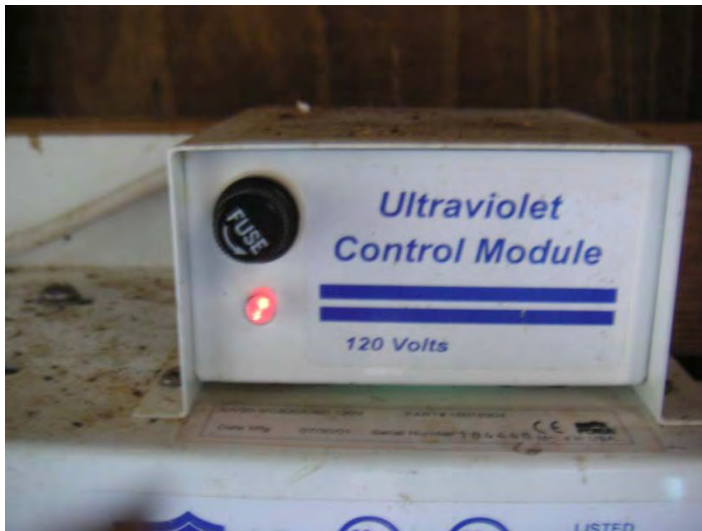
Dirty filters – the red color is probably African dust and the charcoal filter did not get the dust because of the earlier filtration:
