**Wetland Restoration & Park Creation
Parcel 11 Carolina, Coral Bay Quarter,
St. John, U.S. Virgin Islands**

**Gary Ray, Ph.D.
Virgin Forest Restorations**

**For Coral Bay Community Council
Coral Bay, St. John**

October 25, 2012

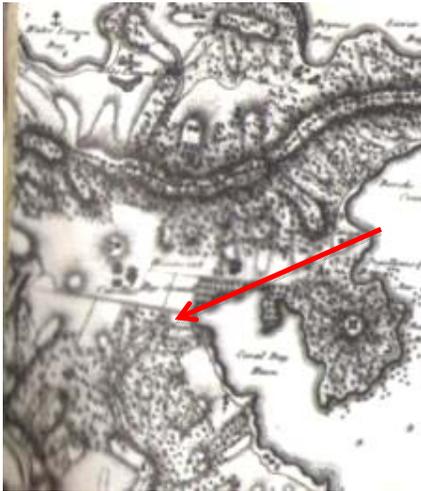
Figure 1. Oxholm Map of 1800, based on 1780 data, depicting areas under cultivation (clear), in pasture (stippled), and in forest (gray and stippled). The restoration site is indicated by a red arrow.

The Oxholm Map of 1800 based on data compiled in 1780, shows the area as cleared for cultivation (Figure 1). Many years ago, a shallow well measuring two meters in diameter, was dug within the current marsh zone, and within 10 m of the northbound lane of Rt. 107. Although rainfall and subsurface flow might bring freshwater into the well basin, tidal influences and lowering the groundwater lens during dry periods would bring ample seawater into the well – making it brackish. At the time of this writing, it was partially filled – its surface covered with water hyacinth (*Eichhornia crassipes*), an aquatic weed.

The restoration ecologist endeavors to visualize the pre-disturbance condition of the site to be restored, and notes coarse-resolution changes over time in those conditions, based primarily on land use history (Figure 1). Also, wetlands, like other natural communities, have distinctive topographic profiles, hydrologic functions, soil types, and botanical components. What's more, wetlands are subject to daily, seasonal and long-term natural changes due to tidal influence, erratic rainfall patterns and climatic shifts over decades to centuries. Observations of these factors assist the restoration ecologist in creating a model for a natural community appropriate to the site, on which native species selection is based.

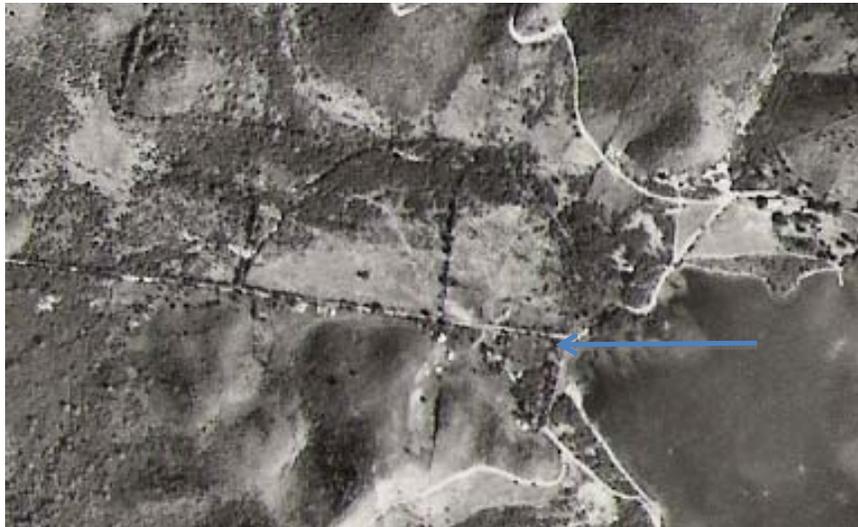
Figure 2. Aerial photograph (1954) of eastern Carolina Valley, showing the restoration site, center-right (indicated by blue arrow). Sparsely vegetated areas were cleared as pasture. Remaining terrain was subject to intensive grazing by livestock.

Some 58 years ago, historic aerial photos show the area with coconut palms along the eastern margin with most of the remainder of the site consisting of herbaceous plant cover (Fig. 6). The only edible fruit other than coconut likely to have occupied the site at the time was soursop (*Annona muricata*). Today, the site exhibits extremely tall coconut palms, some approaching 100 feet, and a plant community infested with weeds and often inhabited by roaming livestock and feral donkeys.

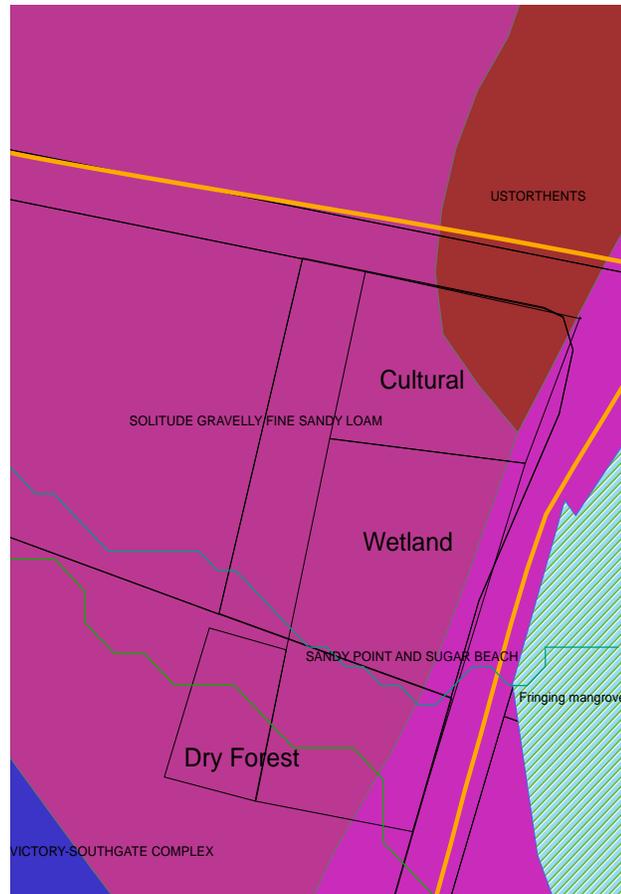
Figure 3. Soil map of the labeled restoration site, including 3 map units: Solitude (burgundy), Sandy Point and Sugar Beach (SBA, magenta), and Ustorthents (brown) (see narrative). Sources: USDA, NRCS Soil Survey of the U.S. Virgin Islands, UVI Conservation Data Center.

The soils of the site have been mapped (Figure 3) as part of the Virgin Islands Soil Survey, commissioned and implemented by the USDA, Soil Conservation Service (presently "Natural Resources Conservation Service) of the early 1990's. While mapping shows horizontal zonation, site conditions show a mixture of the soil map units in the vertically oriented soil profile, i.e. the gray marl and black muck shows at varying depths of a loamy clay profile – a mixture of soil types.

The soil map unit termed: "Solitude Gravelly Fine Sandy Loam, 0-2% slope, frequently flooded" covers more than 90% of the restoration site. These are light olive brown soils occurring in areas adjacent to saline marshes, containing mixtures of terrestrial and marine sediments. They are somewhat poorly drained with moderate organic matter content, low to moderate fertility, and from slightly to strongly saline. They are unsuited from crop cultivation.

The eastern margin of the site consists of “Sandy Point and Sugar Beach, 0-2% slope, frequently flooded”. These soils occur on nearly level saline marshes as a mixture of olive gray sandy clay loams and black muck near the surface with mucky clay loams with depth in the profile. It is unsuitable for crop cultivation.

The northeast corner, where the CBCC will focus on a cultural restoration and park, has been classified as Ustorthents – a map unit that includes areas “altered from their natural state by human activities” (USDA-NRCS 2000), such as filling activities to raise land levels. Soils of areas to the north and east of this site have been raised using heavy earthmoving equipment.

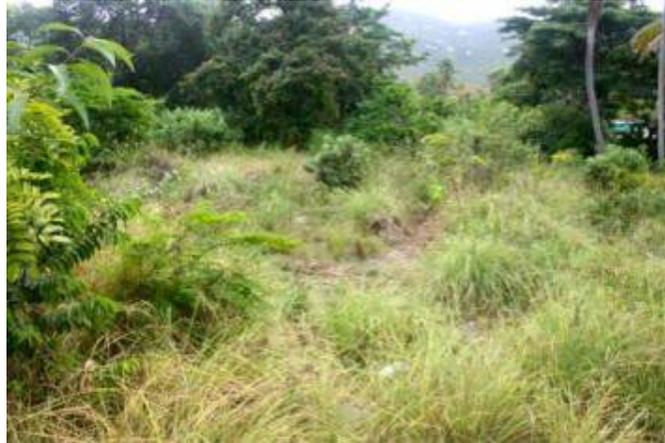
Figure 4. Sedge community dominated by flatleaf flat-sedge (*Cyperus ligularis*) and sticky sedge (*Cyperus elegans*) at the center of the wetland restoration site, Parcel 11, Coral Bay.

One such association is defined by the abundance of sedges (Figure 4) – grass-like herbs of the sedge family, (*Cyperaceae*), that mostly favor frequently flooded sites. The subsoil content is typified by a high amount of gray marl. Plants adapted to the longest periods of flooding, and thus tolerate low oxygen soils, dominate the lowest areas of the local terrain. These species include flatleaf flat-sedge (*Cyperus ligularis*), a 5-foot tall herb growing in tight aggregations some two feet in diameter favoring the more flooded sites, and sticky sedge (*Cyperus elegans*), a smaller herb with similar tolerance of flooding, that fills areas not occupied by the taller sedge. Other sedges include swamp flatsedge (*Cyperus planifolius*), which is similar in height to flatleaf sedge, but far less tolerant to inundation during wet periods. Other rush-like herbs, featuring a very tall, narrow habit include cymose sedge (*Fimbristylis cymosa*) and junquito (*Fimbristylis dichotoma*), are mixed with the taller sedge species on the wettest microsites. A sixth sedge species, scented kyllinga (*Kyllinga odorata*) occurs along the roadside margins. This sedge association is largely intact with few introduced species found within.

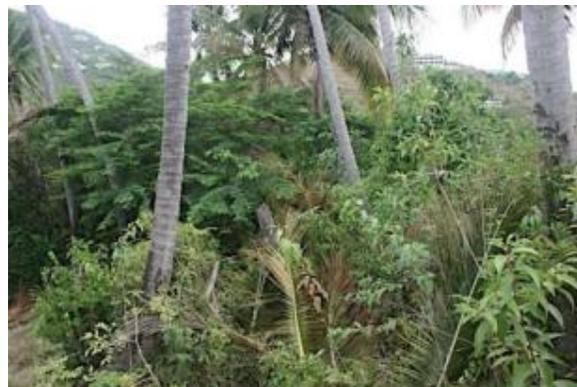
Figure 5. Intermittent canopy of tall coconuts provides feeble shade for more robust growth of shrubs, many of them non-native, in this mixed association at the center of the restoration area.

A second association (Figure 5) is a mixture of shrubs and trees in a zone that is exposed less often to flooding, and contains soils and more land crab holes (burrow entrances) than the sedge zone. This association is variable and highly disturbed by human-related activities, and it cannot be characterized as part of moist forest or dry forest communities. The most frequent shrub is the native salt marsh aster (*Pluchia odorata*). Non-native shrubs include numerous scattered belly-ache bushes (*Jatropha gossypifolia*), and stiver bush (*Senna bicapsularis*). None of these species are palatable to sheep and donkeys; their abundance testifies to intensive grazing pressure. This is a highly anthropogenic (human-engendered) plant community due to domination by these two “disturbance increaser” plant species. Coconut groves are also a significant structural presence, and copious falling fronds and fruits shifts conditions of the ground layer to favor weedy exotics. Soursop trees are scattered throughout this zone.

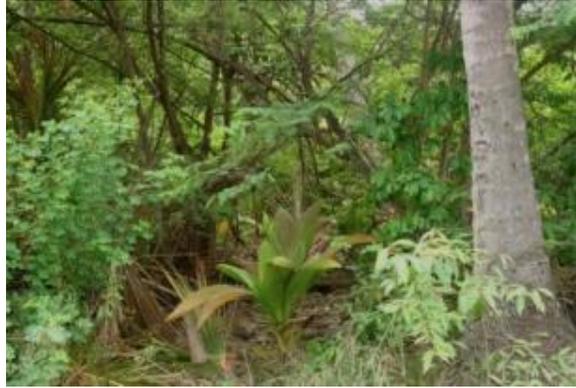
Figure 6. Moist forest area at the southeast corner of the parcel, view to west. Soils are sufficiently deep to retain moisture, and partial flooding clears the ground layer.

A moist association (Figure 6) relies on deeper soils that retain moisture, yet dry out periodically to maintain oxygen content. This community is somewhat abbreviated on the parcel, occupying mostly the southeast corner and a narrow strip along the south boundary. Native trees include angelin (*Andira inermis*), black mampoo (*Guapira fragrans*), white prickly-ash (*Zanthoxylum martinicense*), yellow prickle (*Zanthoxylum monophyllum*) and West Indian elm (*Guazuma ulmifolia*). Scattered through the area were Guyanese wild coffee (*Casearia guianensis*), and tan tan (*Leucaena leucocephala*). Non-native components include coconut and Jumbie bead (*Abrus precatorius*).

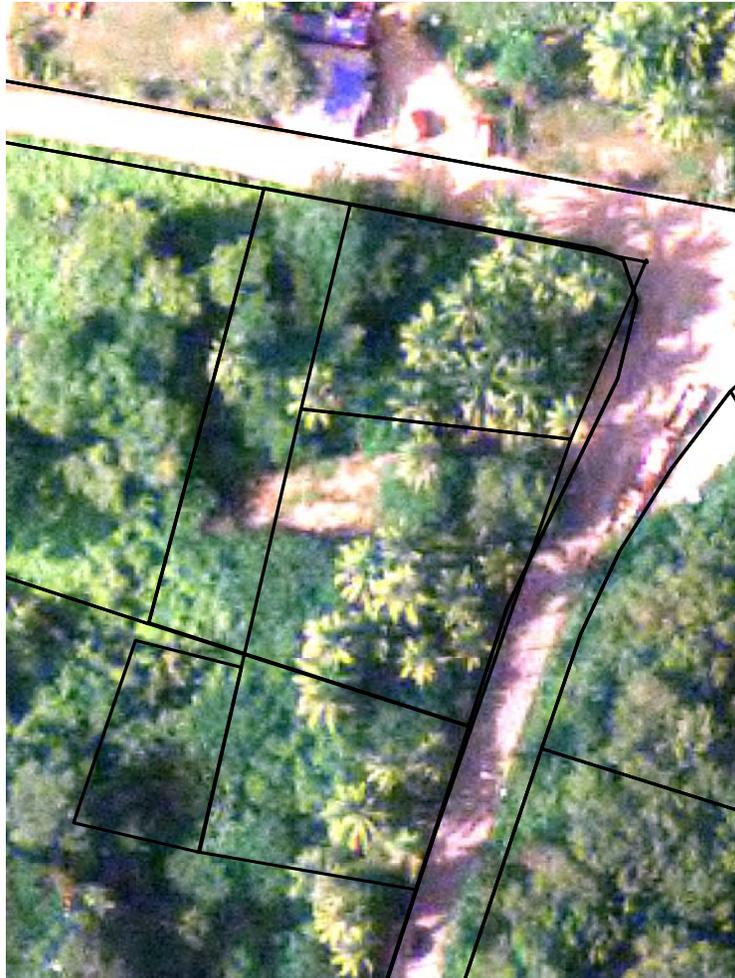
Figure 7. Aerial image of site (parcels are indicated by black lines). Image clearly shows the barren marsh zone, at center, and coconut groves along the eastern section of the site.

We begin with a recent aerial from Google Earth. We divide the parcel into vegetation zones, whose boundaries were located with the aid of “ground-truthing” the site (Figure 7). The cultural restoration is located in the northern section of the parcel bordered on the east and north by Routes 107 and 20, respectively. The brackish marsh, dominated by sedges stretches across the center section. An unsorted area consisting of moist forest species, mostly scattered in the southeast corner and along the south boundary, and shrubby vegetation interrupted by some open areas of weedy herbs covers the southern half of the parcel (Figure 8).

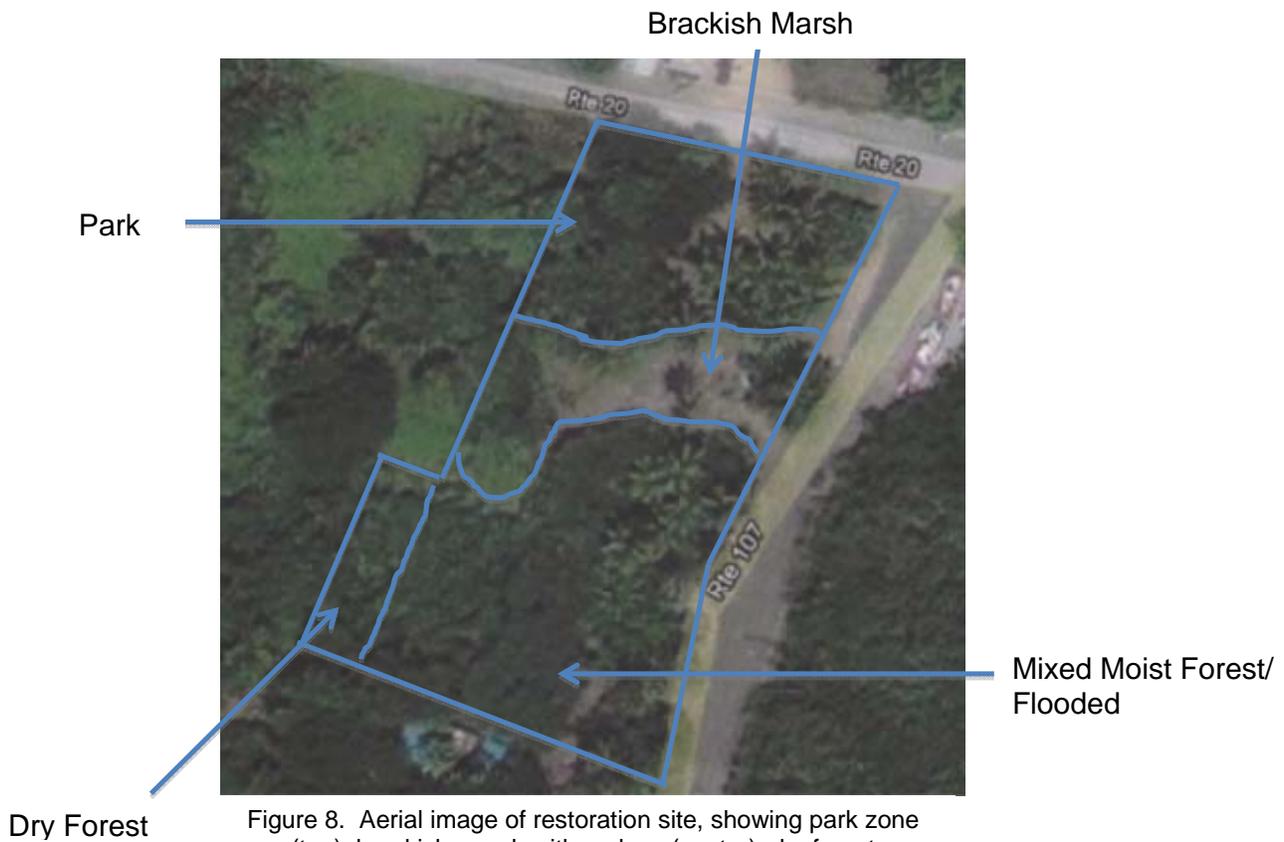
Figure 8. Aerial image of restoration site, showing park zone (top), brackish marsh with sedges (center), dry forest association (left or southwest corner), and mixed moist forest occasionally inundated (southeast section), as indicated by blue arrows.

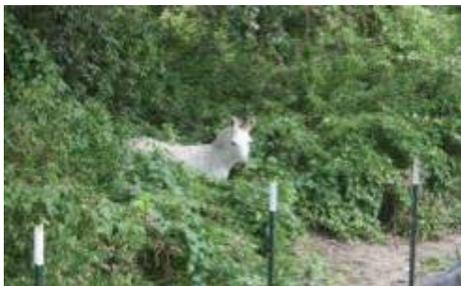
Figure 9a. Feral donkeys and free-roaming livestock heavily graze the site, altering plant species composition to favor non-palatable weeds, while spreading weeds from other areas in their fecal piles

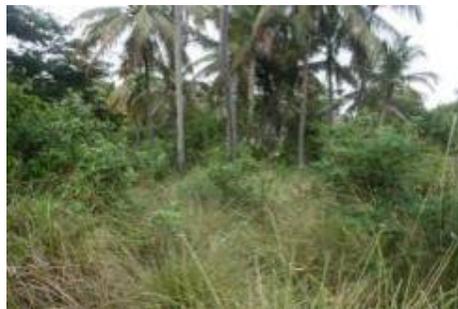
Figure 9b. Coconut (a Pacific Rim species introduced to the island in the 16th century) is present near the roadside at Rt. 107, some attaining heights of nearly 100 feet, presenting some danger to people spending significant time in the park.

From throughout the parcel, we intend to remove all of the invasive exotics, and as many of the less aggressive exotics as achievable, using volunteer assistance. Mexican coral vine, rubber vine, bellyache bush, and Chinese violet are the key target species for removal. Following these, stiver bush, finger grass (*Chloris barbata*) and jumbie bead (*Abrus precatorius*) will be removed. All exotics except coconut will be controlled or removed. Two to three coconut trees may need to be removed in the area planned for public use & children's play (Figure 9b).
